Appendix E
Stained Glass Conditions Report

Femenella and Associates, Inc.

FIRST UNITARIAN SOCIETY OF PLAINFIELD PLAINFIELD, NEW JERSEY

STAINED GLASS WINDOW SURVEY

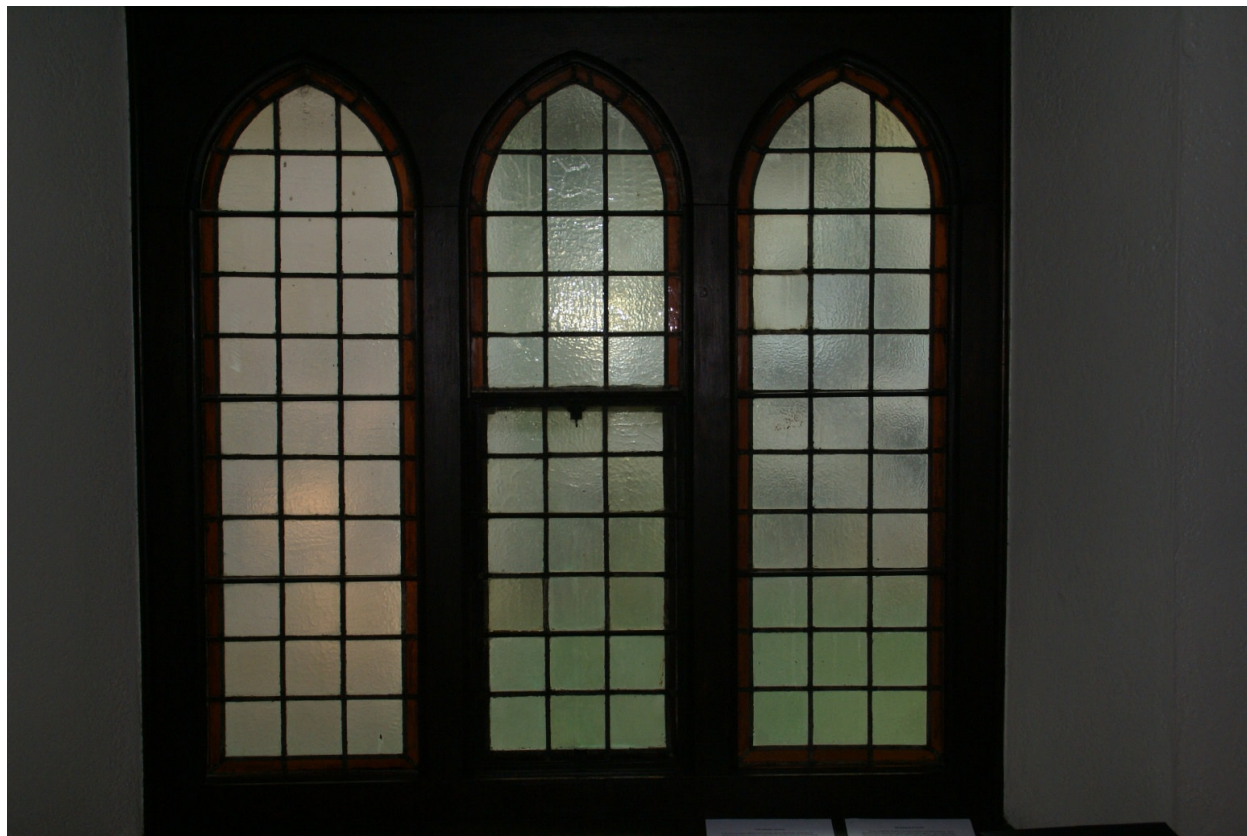
Photo 1 – Leaded Glass

Leaded Glass Windows. Most of the windows in the Sanctuary are leaded glass windows. The distinction between leaded glass and stained glass is that stained glass has one or more pieces of glass that have been painted or stained with a vitreous paint and fired after the glass has been manufactured. Leaded glass, while the glass may have color, has no additionally applied painted or stained surfaces (See Photo 1 – Part IV).

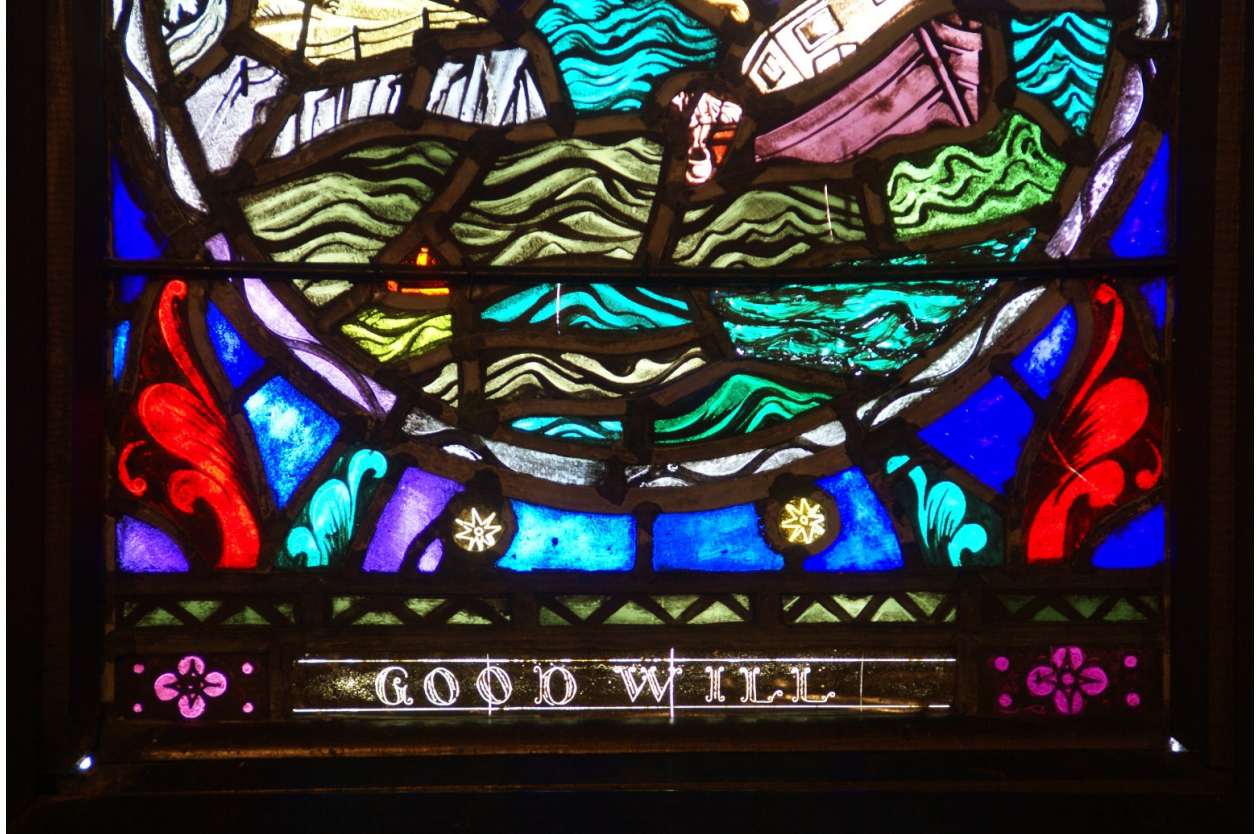
Photo 2 – Stained Glass

Painted and Stained Windows. This group includes two windows made from full antique glass and extensively painted with trace and matte vitreous paint (See Photo 2 – Part IV). Antique glass is more accurately described as mouth blown glass. To fabricate the glass, a large blob of molten glass is held on the end of a long hollow metal tube. The worker then blows air into the blob to form a small bubble. The glass is repeatedly re-heated and more air blown in until the glass has formed a bubble perhaps two feet long. The worker then cuts off the ends of
